Subject: Information Report, FL-233

DEFECT INFORMATION REPORT

FREIGHTLINER CAMPAIGN NO: FL-233

Subject: Notice of Defective Tie Rod Assemblies-NHTSA Recall 99E-005

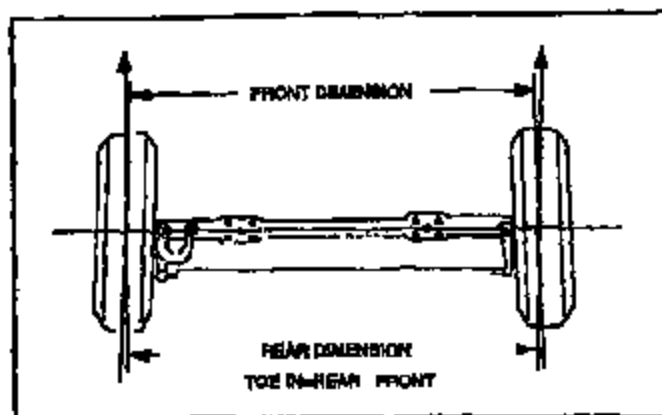
Figure 1.

To obtain accurate reading, two mechanics are required to insure that the pointers are always placed or adjusted to be exactly in front of the line scribed on both tires. Toe-in is the amount in fractions of an inch that the front wheels are closer together at the front than at the back (Figure 1).

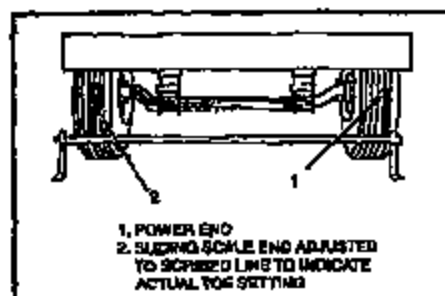
Figure 2.

6. Set the sliding scale end of the transverse bar to zero (0) (Figure 2) and lock the scale in place.

7. Put the tramnel bar at the rear of the front tires so the sliding scale that was set to zero (0) in step 6 is centered against the scribed line on one of the tires (Figure 2).
8. Adjust the pointer on the end of the tramnel bar opposite the sliding scale so it lines up with the scribed line on the rear of the opposite front tire. Lock the pointer in place on the tramnel bar.
9. Put the tramnel bar against the front of the tires so the pointer end is against the scribed line on the front tire. Loosen and remove the sliding scale pointer on the opposite end of the tramnel bar so it is against the scribed line on the opposite tire. Lock the scale in place (Figure 3).
10. Read the toe-in or toe-out on the sliding scale. If toe-in is correct, it will read $1/16 \pm 1/16$ inch.

1. Loosen the tie rod clamps that secure the tie rod ends in position in the tie rod tube.
2. Set the sliding scale on the tramnel bar to read $1/16$ toe-in.
3. Turn the tie rod tube to set the toe-in. After the toe-in is set, the sliding scale and the pointer should both be on the scribed line of the respective tire being adjusted. Page 2.
4. Turn the steering wheel in each direction to center the steering linkage (if the vehicle has power steering, start the engine before turning the wheel). Make sure the front wheels are in a straight-ahead position (stop the engine) and re-check the toe-in setting. Make any necessary adjustments.
5. Repeat step 4 until the toe-in reading is $1/16 \pm 1/16$ inch.
6. Position and tighten the tie rod clamp nuts 70-85 lbs. ft..
